# TECHNICAL INFORMATION

## CRACKS: THE HIDDEN DEFECT

by John Maxwell  
AVX Corporation

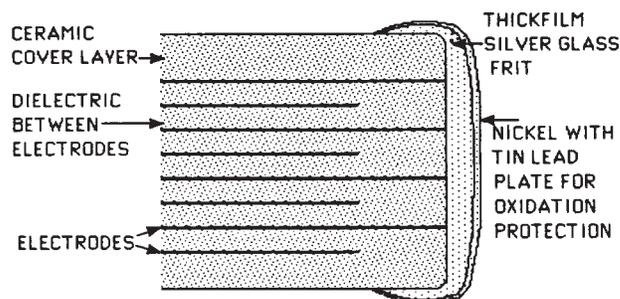
Figure 1. MLC Structure

Multilayer ceramic capacitors are sensitive to thermal shock due to device construction consisting of interleaved layers of ceramic dielectric and metal electrodes with metal terminations for electrical contact. This structure has been described earlier.<sup>3</sup> (See Figures 1 and 2)

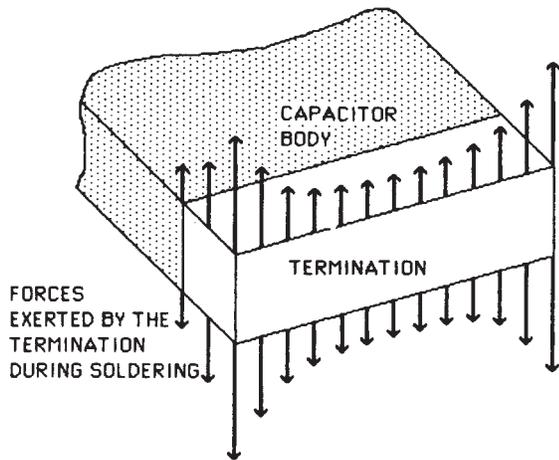
Figure 3. Stress Risers Caused by the Termination on the MLC Body

Compatible materials used in MLC manufacture have differences in CTE and  $\delta T$  that cause internal stress. When the temperature rate of change is too great, thermal shock cracks occur. These cracks are initiated where the structure is weakest and mechanical stress is concentrated. This is at or near the ceramic/termination interface in the middle of the exposed termination. Mechanical stress is greatest at the corners where the chip is strongest but cracks tend to start where the structure is weakest. When temperature rates of change are excessive, as in uncontrolled wave soldering, large visible U-shaped or thumb-nail surface cracks are formed.

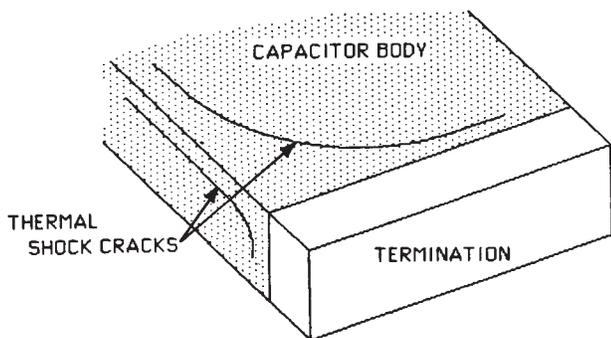
Figure 4. Extreme Thermal Shock Cracks in MLCs

Thermal shock has two manifestations, obvious visible cracks (Figure 4) and the more insidious, invisible micro crack (Figure 5). The same forces are involved but on a smaller magnitude so smaller cracks are formed. Again it starts in the middle of the exposed surface at or just under the ceramic/termination interface and propagates slowly with temperature changes or assembly flexure during handling. In a matter of weeks a micro crack can propagate through the ceramic causing opens, intermittents or excessive leakage currents, a time bomb due to processing (Figure 6).

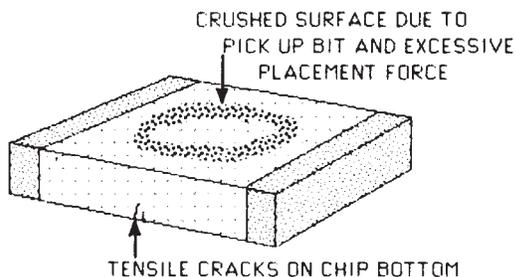
Figure 7. Placement Bit Damage With Tensile Cracks

Damage or cracks caused by vacuum pick-up bits is straightforward and obvious (Figure 7). It usually consists of a crushed circular- or halfmoon-shaped area on the exposed surface of the chip and is usually quite rough with ragged edges or can be a visible impression of the placement bit. Additionally the halfmoon or circular areas will match the bit diameter. Another manifestation of bit damage occurs where solder paste is used on reflow soldered boards. Tensile cracks may be found originating on the board side of the component going from side to side in the middle of the part. These cracks may propagate to the top surface and will be rough or ragged with possible pieces of the capacitor burst from its bottom surface and trapped between the capacitor and board. This is a case where the solder paste has supported the capacitor ends but not the middle, allowing the unsupported component body to crack.

This type of damage is caused by excessive Z-axis placement force of the bit that exceeds the rupture strength of the ceramic. Many pick and place machines use small bits (increased pounds/sq. inch) which compounds the problem by reducing the process window to avoid damage. There are two basic methods used for placement force: programmed Z-axis displacement, and pneumatic actuators. When Z-axis displacement is used for parts placement, component thickness variations, board (substrate) warpage, component land plating and solder paste thickness variations are the usual culprits. Pneumatic actuators have a separate set of problems that also include component thickness variations and warped boards. Air pressure variations within the plant can be a major cause of excessive placement pressure cracks. Also as the air cylinders age, they get sticky or suffer pressure loss, both of which are compensated for with increased air pressure and excessive force placement defects. Z-axis placement force is a process parameter that requires mandatory monitoring and control.

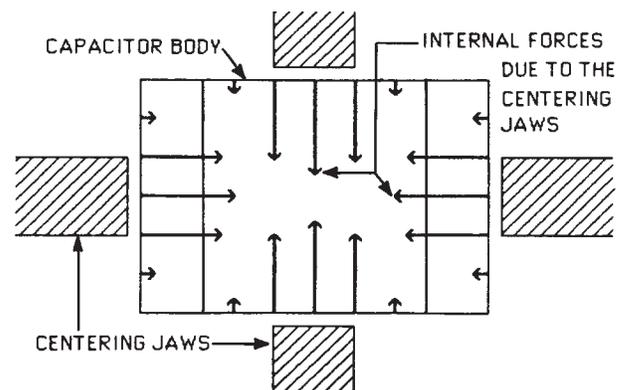
Figure 8. Top View of Capacitor Body, Centering Jaws and Force Concentration

Top centering jaw machines have the alignment jaws or tweezers as part of the pick up mechanism (Figure 8) such that the part is centered (aligned) when plucked from the component carrier (embossed tape, etc.) or during the travel time between pick up and placement. Capacitors, resistors, transistors and integrated circuits (IC) require different sizes of centering jaws which slow production rates with jaw changes. It is common practice to adjust a single jaw set to accommodate the full range of components which results in higher forces on smaller parts when the jaws are adjusted to center large ICs. Not only are higher forces used but the jaw contact areas are reduced so centering is done only on the IC body and not the leads. Now only a small portion of a capacitor's side and end surface area is used for centering which gives rise to pressures that exceed the rupture or tensile strength of the ceramic causing internal defects and visible cracks (Figure 9).

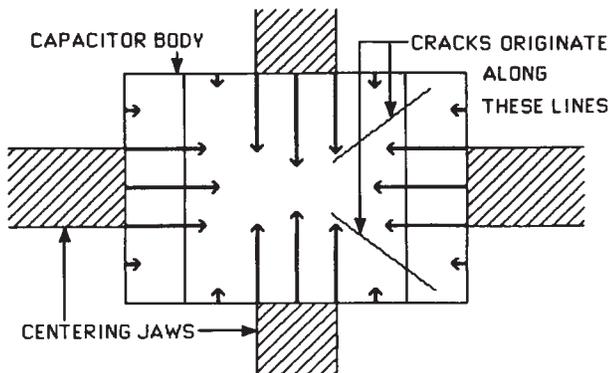
Figure 10. Surface Crack Origins

These force concentrations from narrow centering jaws create large force or shear gradients where cracks develop. These cracks manifest themselves as visible surface cracks or internal cracks between two or three electrodes. Surface cracks originate along lines of maximum compression and ceramic displacement (Figure 10).

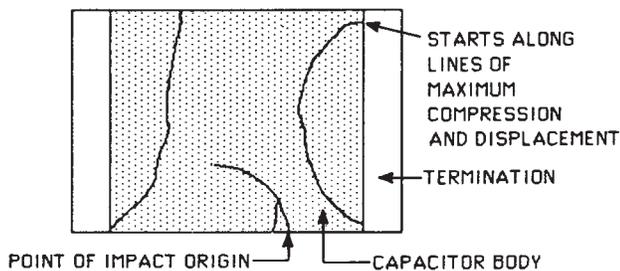
Figure 11. Typical Surface Cracks from Top Centering Jaws

Top centering jaw machines generate surface cracks that typically originate or end under the termination while thermal shock cracks radiate away from the termination with a thumbnail- or U-shape. Centering jaw cracks will typically not extend beyond 1/3 to 1/2 of the chip length. These are quick clues to determine the source of cracks. Figure 11 illustrates typical top centering jaw damage after soldering.

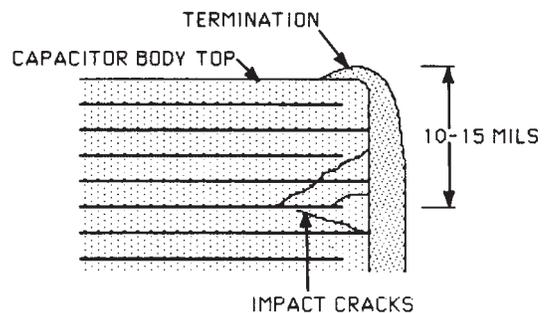
Figure 12. Typical Internal Centering Jaw Damage

Some impact site cracks are easy to find with DPA when the centering jaw forces are low enough to just cause invisible damage. Typically these cracks have obvious origins 10-15 mils below the top surface which will be the bottom of the centering jaws, again the region of maximum stress gradients. These cracks may be deeper than 10-15 mils depending on the centering jaw depth but they will have their origins at the bottom of the jaw.

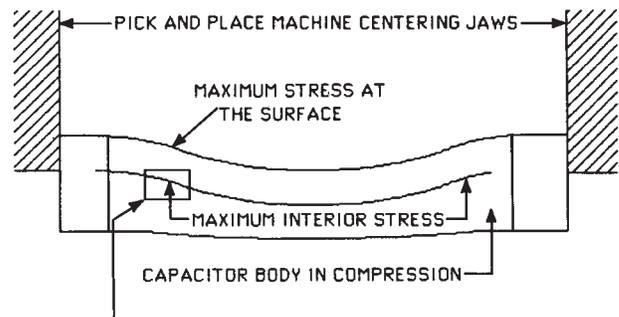
See Figure 14.

Figure 13. Capacitor Under Compression from Centering Jaws

Inter-electrode defects are the most difficult to find with DPA but they too occur at the same depth as the more obvious cracks, at the bottom depth of the centering jaws. These small cracks are again 10-15 mils below the surface (or jaw depth), near the maximum stress gradients exerted by the centering jaw. The capacitor body is slightly deformed by the compressive forces of the centering jaws. This deformation is similar to pressing on the ends of a deck of cards, and has three inflection points for this type of compression. A small crack will form between two or possibly three electrodes when the ceramic layer ruptures, relieving the stress. A small internal defect that is very difficult to find but can still kill reliability (Figures 13 and 14).

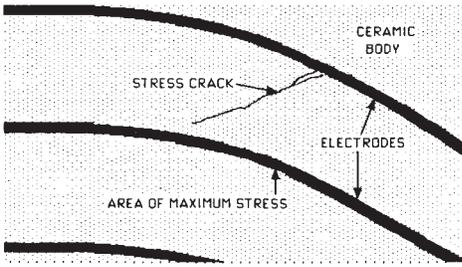
Figure 14. Exaggerated Inter-Electrode Distortion

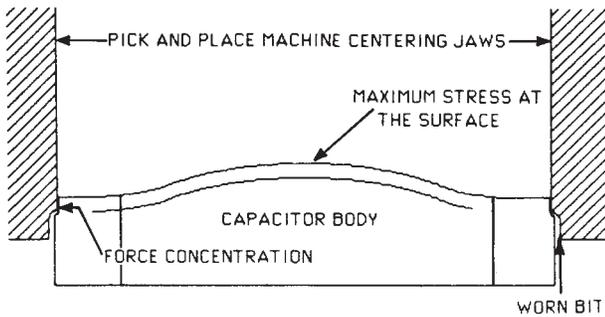
Figure 15. Worn Centering Jaws and Capacitor Distortion

Ceramics used to make MLC capacitors have excellent abrasion characteristics which cause centering jaw wear (Figure 15). Once this wear becomes pronounced (a tenth of a mil or so), a new type of crack can appear even though the equipment has not generated defects in the past. This problem shows up when capacitor lots or vendors are changed and the parts are now slightly thicker. Now all of the force is concentrated in the top few mils, the rupture strength is exceeded and the part cracks. Worn centering jaw induced cracks are typically in the middle of the part extending from side to side on the top surface (Figure 16).

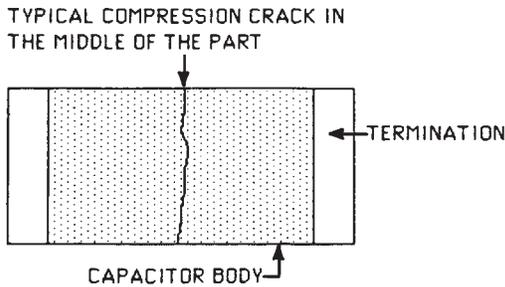
Figure 16. Typical Worn Centering Jaw Crack

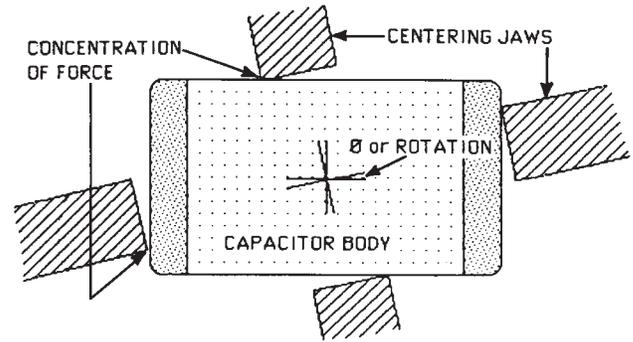
Figure 17. Misalignment of Component

Another type of damage caused by narrow top centering jaws comes about when the part is slightly rotated in its embossed tape pocket. Now all centering or alignment forces are concentrated at the sharp corners of the jaws causing chip-outs at the impact sites. There may be cracks radiating away from the impact sites on the top surface that show up after exposure to soldering temperatures (Figures 17 and 18).

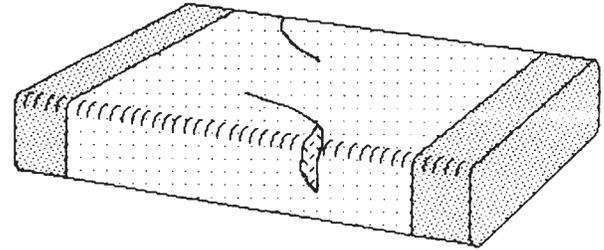
Figure 18. Resulting Damage

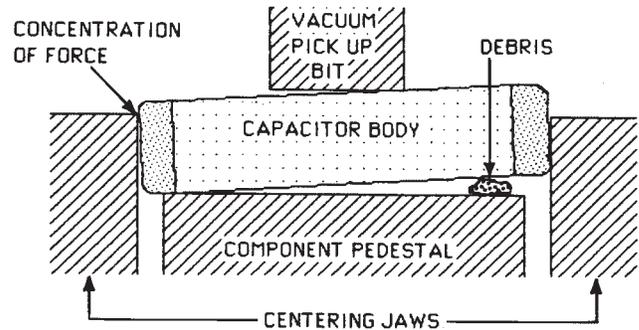
Figure 19. Bottom Centering Jaws With Debris

We're not out of the woods yet with pick and place machine damage. Bottom centering jaws found on some high volume chip shooting machines also have a unique centering stress crack. These cracks appear and disappear at random intervals and have been tracked to debris buildup on the component pedestal (Figure 19). When debris is present, the component will not be flat or square to the centering jaws, concentrating the alignment forces on a corner causing a displacement crack.

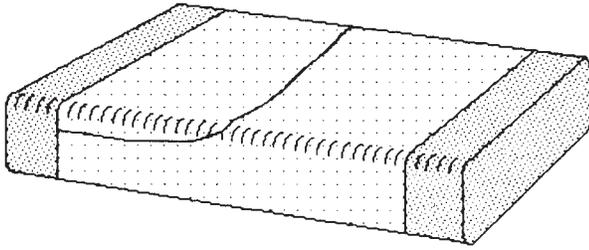
Figure 20. Typical Bottom Centering Crack

This crack propagates from side to side on the top surface (Figure 20) and is similar to surface rupture cracks caused by worn top centering jaw machines. Bottom centering cracks also extend along one or both sides of the part near the surface into the termination. These cracks are eliminated with a rigid cleaning and maintenance regime.

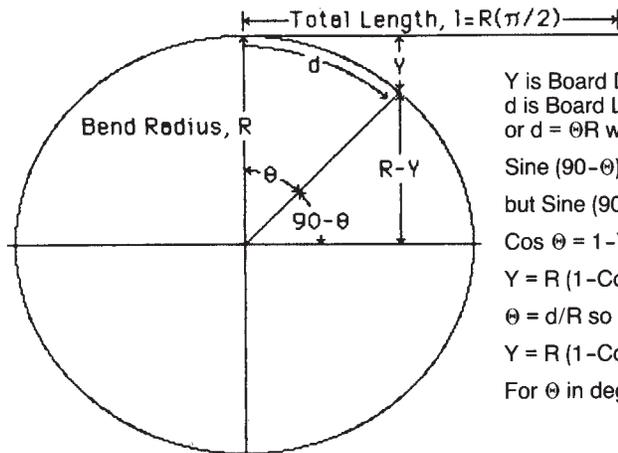
### MAXIMUM BOARD DEFLECTION FOR A GIVEN MINIMUM BEND RADIUS

Y is Board Deflection  
d is Board Length  
or  $d = \theta R$  with  $\theta$  in radians

$\text{Sine } (90-\theta) = (R-Y)/R = 1-Y/R$   
but  $\text{Sine } (90-X) = \text{Cos } X$  so  
 $\text{Cos } \theta = 1-Y/R$  or  
 $Y = R(1-\text{Cos } \theta)$   
 $\theta = d/R$  so  
 $Y = R(1-\text{Cos } (d/R))$   
For  $\theta$  in degrees,  $\theta = 90(d/R)/(\pi/2)$

Allowable bending of finished assemblies is another specification that cannot be an extension of thru hole technology because the entire component is exposed to stress. There are two possible approaches to board bending specifications: a linear mils/inch, or a more realistic minimum bend radius. (See insert.)

Minimum bend radius has a very small allowable deflection in a short segment length but allows a large deflection in long assemblies. For example, a one-inch long segment can have no more than 8.4 mils of uniform bend with a 60-inch minimum bend radius but a four inch long board can have 124 mils of uniform bend. Uniform bend is where the board fits smoothly along the radius of a circle. If there are rigid components like large ICs (integrated circuits), transformers or connectors, then less deflection is allowed for a given board length to eliminate defects. A derivation of allowable deflection based on assembly length and bend radius is in the box below.

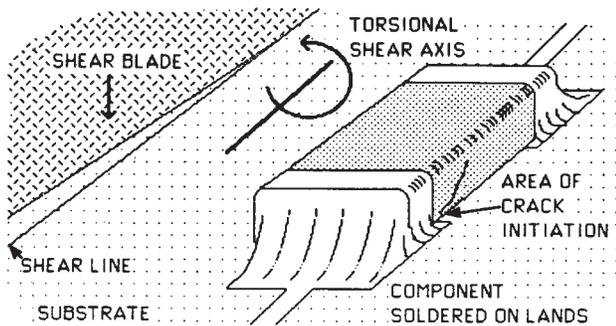
Figure 21. Typical Board Shearing Crack

assembly techniques and is actually an extension from a sheet metal shop. There is a great deal of board bending and tearing near shear blades that can crack components and solder joints. This shearing technique can be used with care but at the loss of board real estate by placing components away from flexing edge and corners. Components located near assembly corners will receive the greatest stress because the corners are the least supported portion of the board and each corner is cut twice, once in the X direction and once in Y. Cracks generated during board shearing typically run diagonally across the top surface from corner to corner.

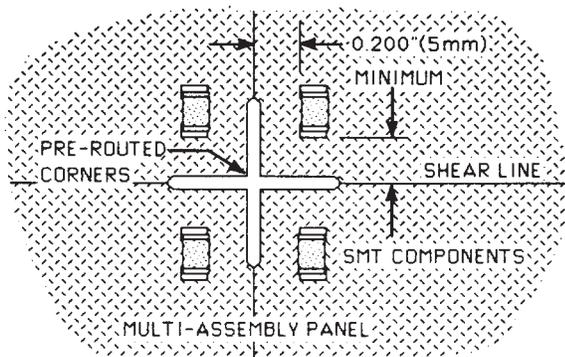
Figure 22. Prerouted Corners to Relieve Stress

Isolating components from board corners and away from edges is the best way to minimize shear damage and leave room for fixturing to reduce movement during the shearing process. Prerouting corners will further reduce stress and flexure in the critical corner areas. Leaving a 200-mil margin has been used successfully to eliminate damage while a 20-mil margin has always failed (Figure 22).

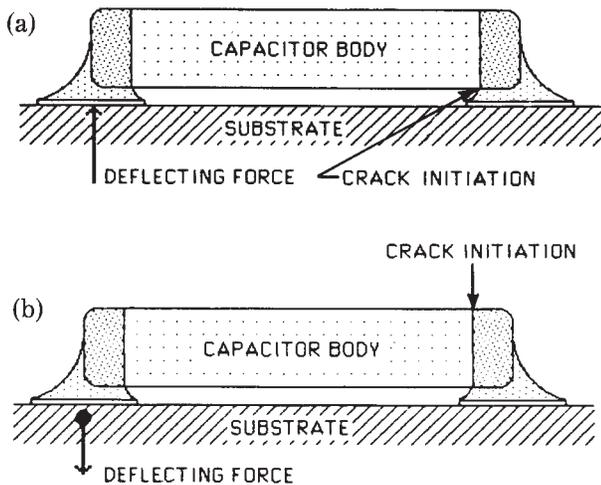
Figure 23. Crack Initiation Sites

The resulting cracks occur very quickly with an audible snap. Depending on board warp, direction and component orientation, these defects propagate to relieve stress. Cracks initiate at the ceramic termination interface where ceramic movement is restricted by the termination and solder fillet. Because ceramic fails in the tensile mode at lower forces (10kpsi tensile vs 15kpsi compression), crack initiation will typically be at maximum tensile force sites as shown in Figure 23.

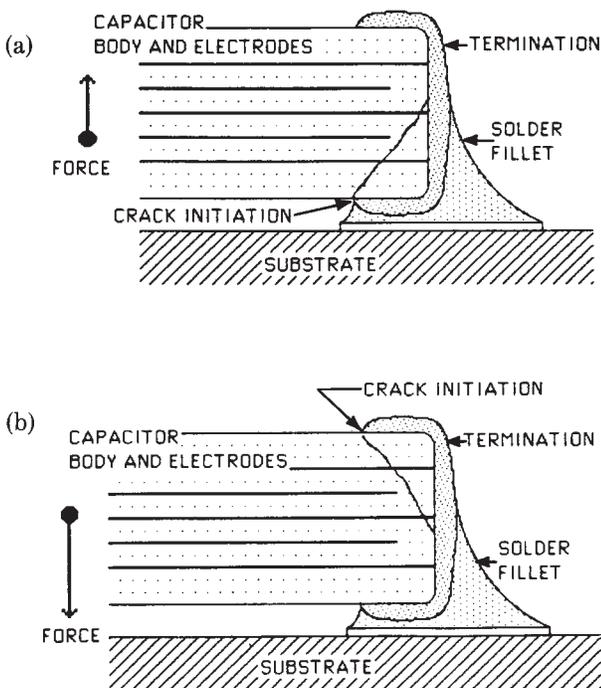
Figure 24. Typical Board Warpage Cracks

The resulting crack propagates from the initiation site to the termination at about a 45° angle. When DPA is done on this type it is confused with thermal shock or possible pick and place damage. Thermal shock cracks typically propagate from termination to termination and pick and place cracks under the termination exhibit multiple fractures while board warp cracks typically consist of a single crack.
